**ALEUTIAN ISLANDS HOUSING AUTHORITY**  
**TRIP REPORT:**  
**ST. PAUL ISLAND, FALSE PASS AND KING COVE**  
**Assessment of Mold and Moisture Conditions**

**Final Report**

Date:  
August 16-20, 2004

*Prepared for:*  
U.S. Department of Housing & Urban Development  
Office of Native American Programs

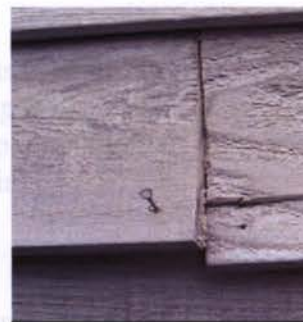
**Figure 6: Loose siding**

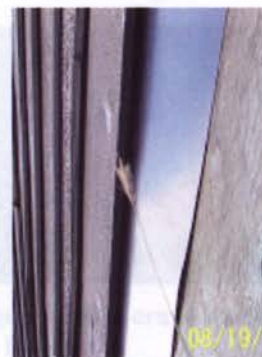
**Figure 7: Loose siding and flashing allowing water infiltration**

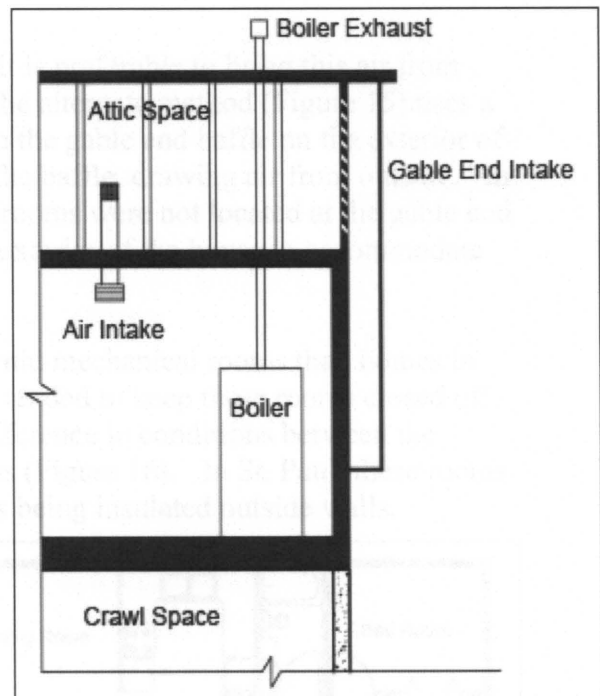
6. When the mechanical units call for combustion air, air from the attic, now possibly contaminated with mold, is drawn into the mechanical room.

Figure 14: Existing - Combustion air intake from attic

6. Combustion air was usually drawn from the attic. The direct link between the mechanical room and the attic allowed moist air from the mechanical room and laundry into the attic. Installing ducting to bring the combustion air from outside will eliminate the minor mold problems found on the roof sheathing.

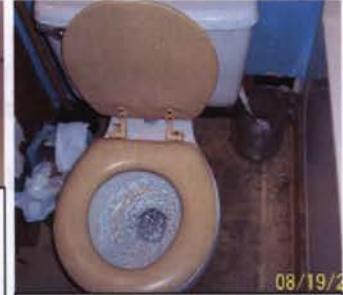
Figure 3: Toilet leaks and wall deterioration

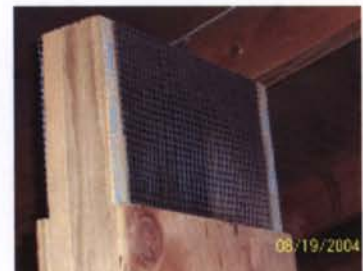
Figure 6: Combustion air intake in attic

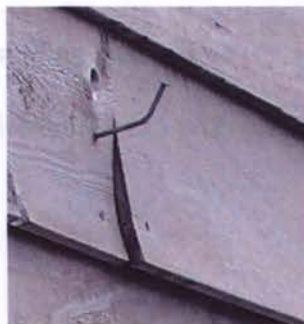
Figure 6: Siding problems

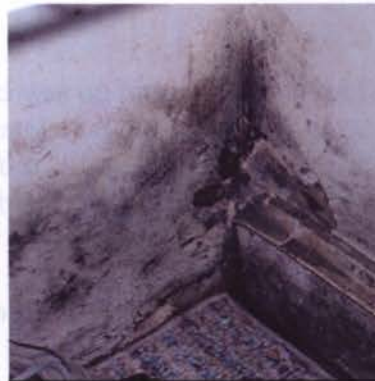
**Conditions:** There was moisture damage and mold in the front entry area (Figure 2), at some of the window jambs (Figure 3), at the marriage joint (Figure 4) and in the kitchen sink base cabinet (Figure 5).

Figure 2: Mold at base of a wall in the entry

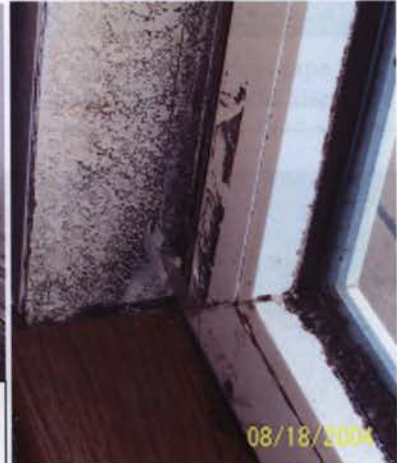
Figure 3: Mold at window jamb

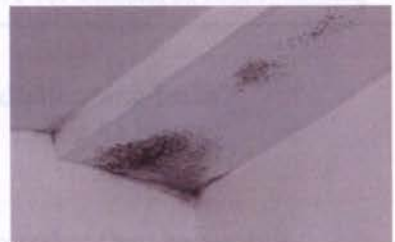
Figure 4: Mold at marriage joint

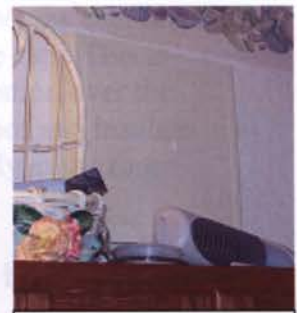
Figure 7: Constrained bath fan

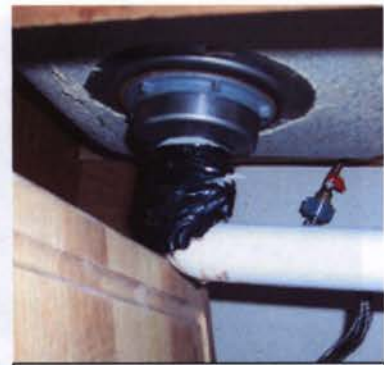
Figure 8: Electrical tape plumbing repairs in kitchen

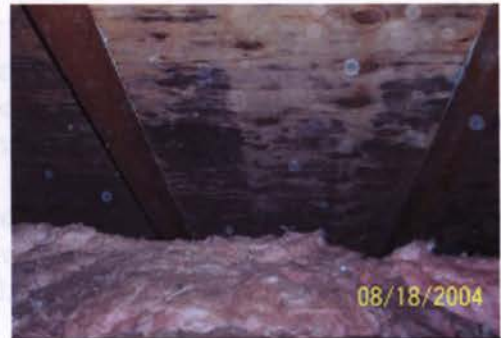
Figure 10: Discolored roof sheathing

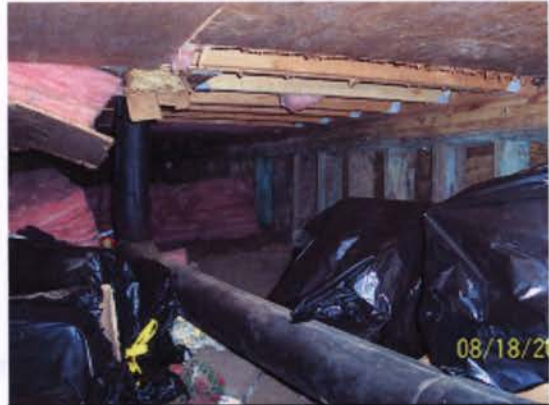
**Figure 11: Missing insulation & clutter in crawl space**

4. Clean all cardboard boxes and other exposed organic matter from beneath the home. If this area is to be used for storage, use plastic airtight containers to store goods in (Figure 11).

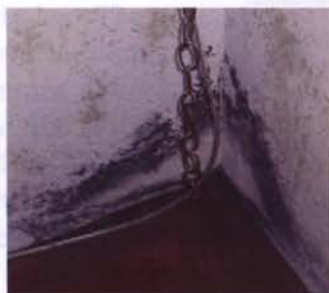
Figure 3: Mold at base of wall opposite entry wall

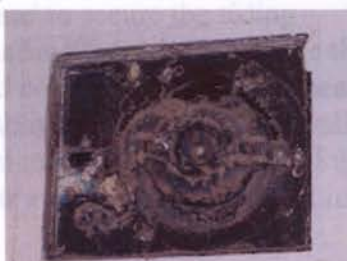
Figure 8: Dirty bath fan

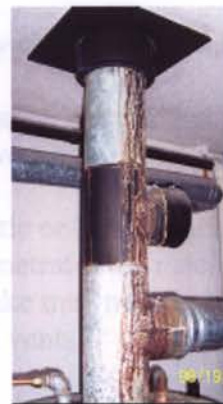
**Figure 10: Rusty  
boiler flue**

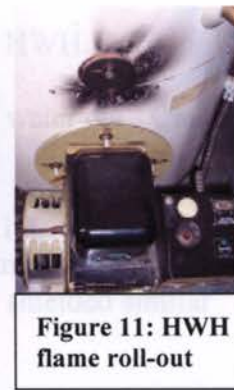
**Figure 11: HWH  
flame roll-out**

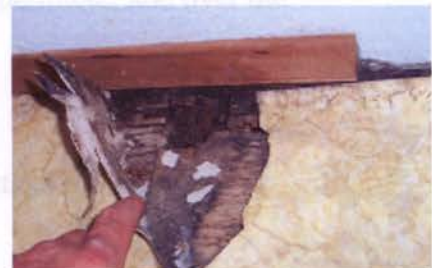
**Figure 13: Rotting subfloor**

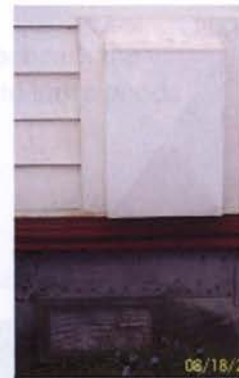
**Exterior Conditions:** The home exterior was in good condition except the boiler flue cap was missing. The dryer vented directly above the crawl space vent (Figure 4).

Figure 4: Dryer vent above crawl space vent

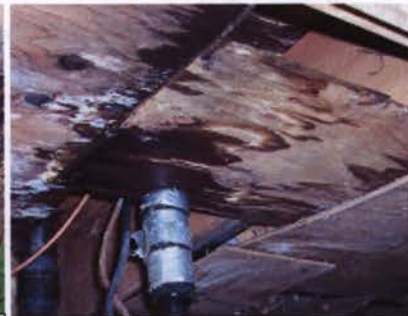
Figure 3: Wet belly board beneath mechanical room and bath

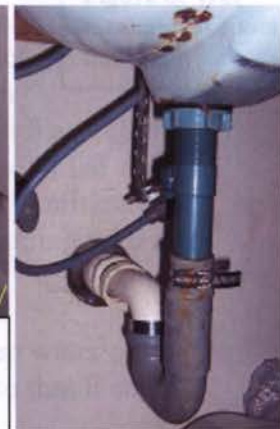
Figure 5: Poor repair of the vanity waste pipes

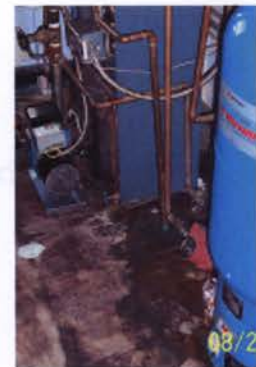
Figure 8: Wet mechanical room floor

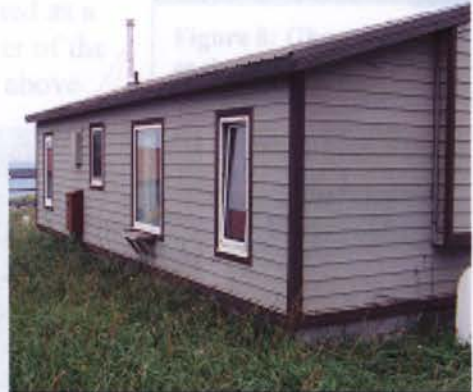
**Site Drainage and Rainwater Management:** No gutter system was present (Figure 2). The site surrounding the home was fairly flat.

Figure 2: Rear elevation and no gutter system

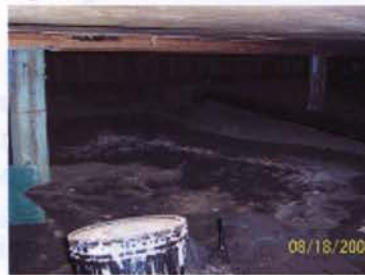
Figure 3: Wet crawl space

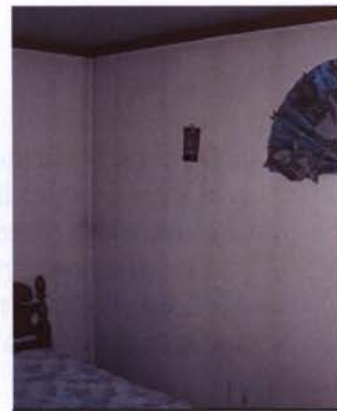
**Figure 8: Ghosting on each stud**

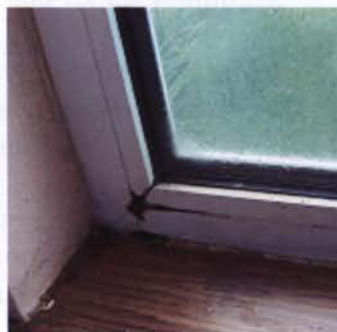
**Figure 9: Condensation on window**

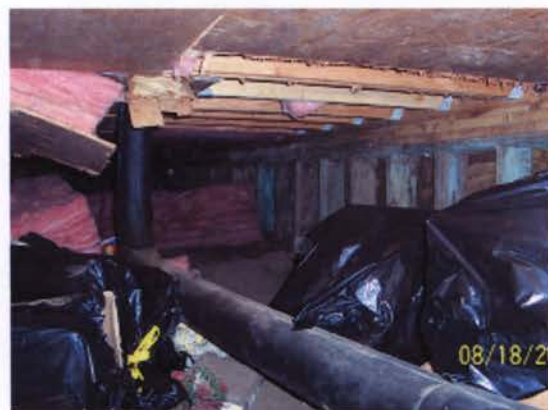
**Figure 11: Missing insulation & clutter in crawl space**

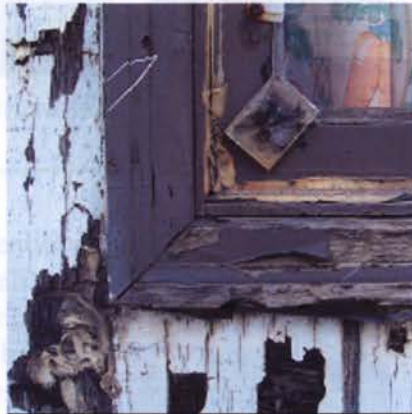
Figure 2: Rotted siding and windows

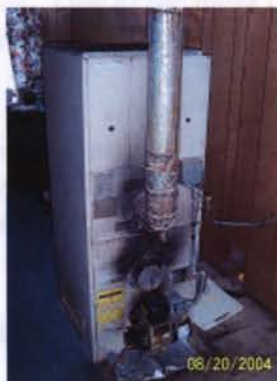
Figure 6: Furnace in living room

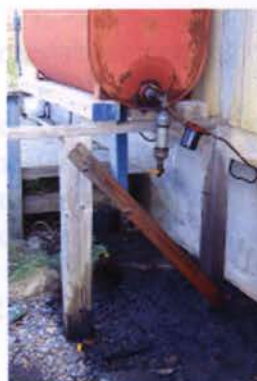
Figure 9: Leaky fuel storage tank

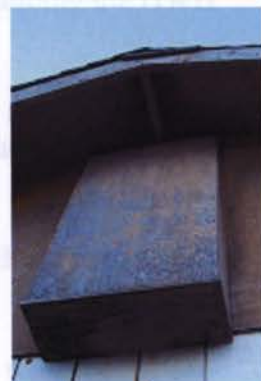
Figure 12: Sealed gable end vent

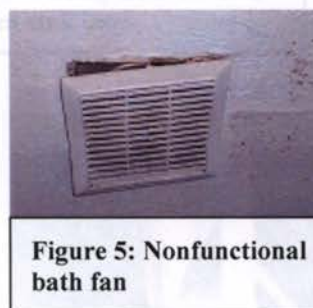
Figure 5: Nonfunctional bath fan

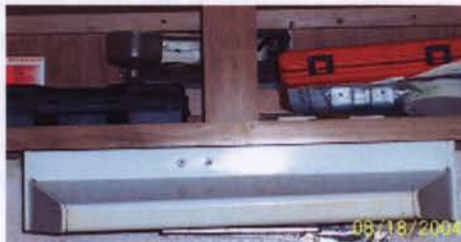
Figure 7: Nonfunctional range hood, note duct in cabinet above

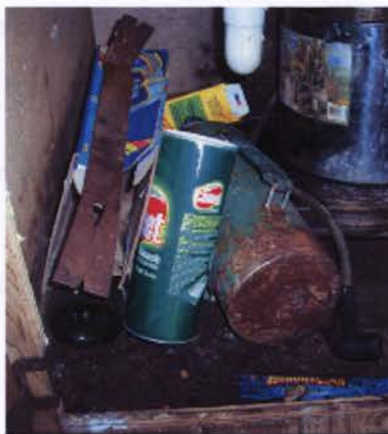
Figure 9: Badly deteriorated kitchen sink base

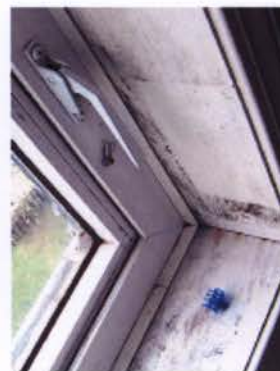
Figure 12: Window condensation and mold on jamb
